IMPROVED LAYOUT FOR A FOWL PROCESSING PLANT

Marketing Research Report No. 973

Agricultural Research Service
UNITED STATES DEPARTMENT OF AGRICULTURE

By Jesse W. Goble, agricultural marketing specialist, Dairy and Poultry Products Marketing Laboratory, Northeastern Region, Agricultural Research Service¹

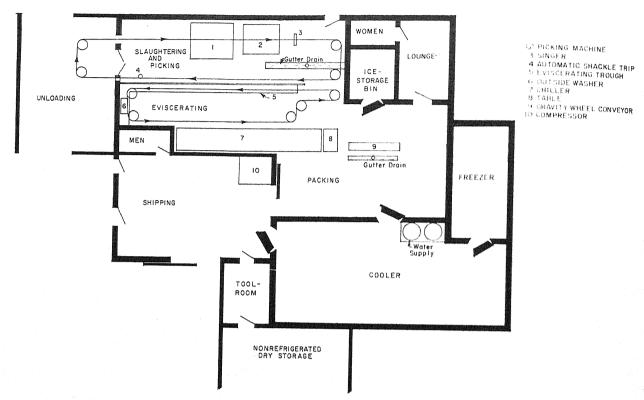
The building (fig. 1) contains 4,786 square feet of floorspace and is constructed at ground level. Because the ground slopes, the floor at one side of the building is at truck-bed height where loading and unloading occur. The building is made of concrete blocks except the dry storage area, which is of wood with a 10-foot-high ceiling. Some room ceilings are 9 and others 13 feet high.

Figure 1.- Layout of the existing plant.

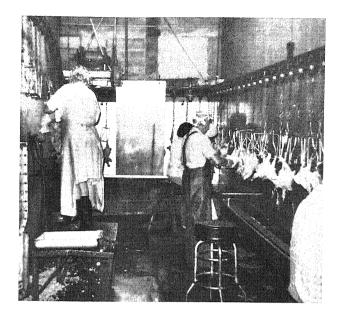
Eviscerating.—The eviscerating area is congested (fig. 2). Water on the floor must pass beneath the metal partition between the slaughtering and picking area and the eviscerating area to reach the gutter drain at the end of the picking area. The ceiling is 13 feet high except for a small area that is only 9 feet high.

Figure 2.-Worker at left removes birds from eviscerating shackles and drops them into the chiller. Note the congestion in the area.

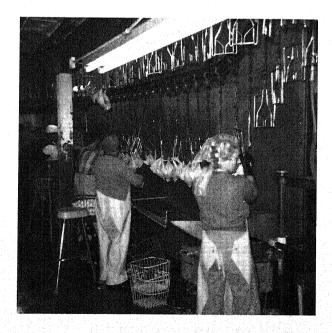
A narrow L-shaped eviscerating trough is located against the metal partition that separates the eviscerating area from the slaughtering and picking area and along the far wall of the eviscerating area (fig. 3). Offal flows from the forward end of the eviscerating trough into a perforated container, which allows the water to drain onto the floor. Periodically the offal is

Figure 3.—One section of L-shaped eviscerating trough is next to metal partition.

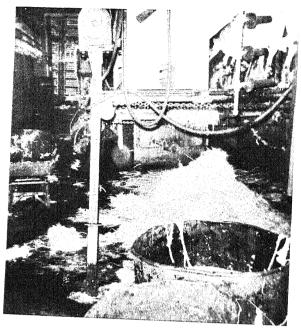
removed manually from the container and held temporarily in barrels located in the picking area near the picking machine (fig. 4).

Figure 4.—Offal is accumulated in barrels near the picking machine.

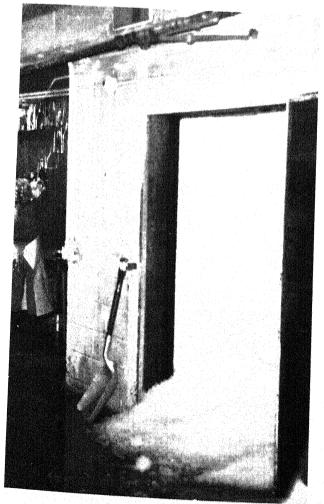
A flake ice machine is located on the roof above the packing area so the ice can drop into the storage bin, which is at floor level adjacent to the packing area. When the door to the icestorage bin is opened, ice often spills out onto the floor of the packing area (fig. 5).

Figure 5.—Ice is discharged onto floor of packing area when door of ice-storage bin is opened.
